# Three drainage areas within the jurisdiction

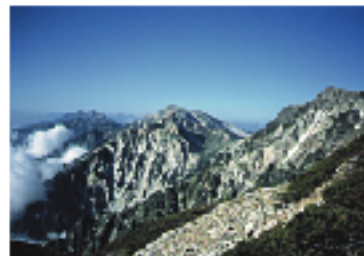
## Drainage area of the Himekawa River

Length of river channel: 46km  
Catchment area: 691.2km<sup>2</sup>  
(upper stream of Yamamoto bridge)  
Average bed slope: 1/16

## Alluvial fan developed because of many rapids and branches

The Himekawa River has its source in the southern part of Hakuba Village. Gathering many small branches together, it runs from the northern part of Nagano prefecture through the southern part of Niigata prefecture all the way to the Japan Sea. The upper reaches of the river are the steep mountain area. The branches with heavy sediment discharge form a lot of alluvial fans. In the middle reaches, Mt. Hieda that is the site of great collapse discharges a large quantity of sediment. The Himekawa River that runs almost along the "Itoigawa-Shizuoka tectonic line" is one of the fastest flowing rapids in Japan with incessant occurrence of disasters.

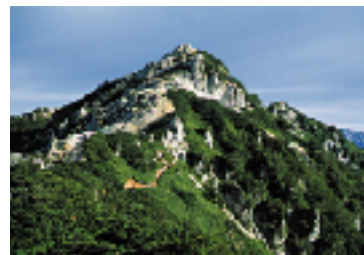
## Drainage area of the Takasegawa River

Length of river channel: 31km  
Catchment area: 350 km<sup>2</sup>  
(upper stream of Takase bridge)  
Average bed slope: 1/13

## Nature of the rock vulnerable to weathering and steep slope

The drainage area of the Takasegawa River is made up of three drainage areas including the Honkawa River that flows out of Mt. Yariadake plus two other branches. The geological features in the drainage area are mostly the granite that is vulnerable to weathering. Moreover, the forests are hard to grow on the mountain ridge in the upper reaches of the river, and the rocks are exposed. For this reason, the shallow landslide and the torrent erosion are in progress. Weathering through the action of a hot spring is added to this, and the sediment is discharged repeatedly during every rainfall accompanied by the steep slope of the canyon, which often causes a disaster.

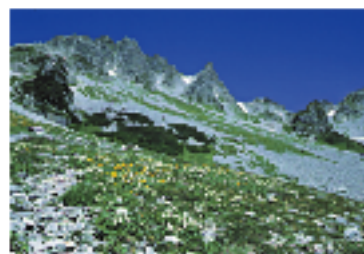
## Drainage area of the Azusagawa River

Length of river channel: 50km  
Catchment area: 559 km<sup>2</sup>  
(upper stream of Shinbuchi bridge)  
Average bed slope: 1/20

## Sediment accumulation in the devastated upper reaches

Five branches join the Azusagawa River that has its source in Mt. Yariadake. The mountainous region in the upper reaches is extremely devastated by the volcanic eruption and through the action of a hot spring, etc., and a large quantity of sediment is accumulated there. The ejecta from Mt. Yariadake have often flowed down the slope as debris flow. Besides, the granite in the drainage area has weathered considerably, which makes the area vulnerable to a disaster when coupled with the lay of the land where many small-scale valleys develop.
