# Major disasters in the drainage area

## Major disasters in recent years

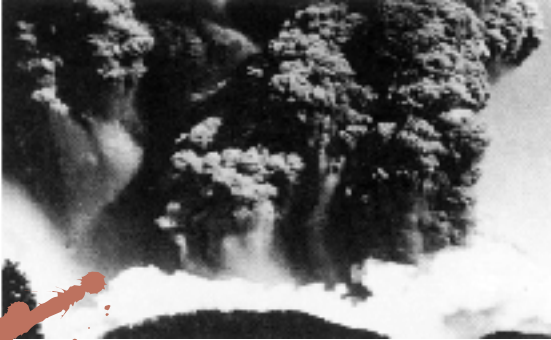
June 4, 1915

## Great eruption of Mt. Yakedake

The great eruption of Mt. Yakedake. A mudflow following the collapse dammed up the Azusagawa River, and caused the breach and the flood to the river. The sediment that flowed down the slope during that time dammed up the Azusagawa River to give birth to Taishoike Pond in Kamikochi.

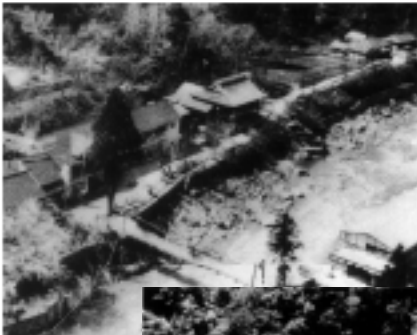
Before the disaster  
(Photos taken by Mr. Yamamoto in Omachi City)

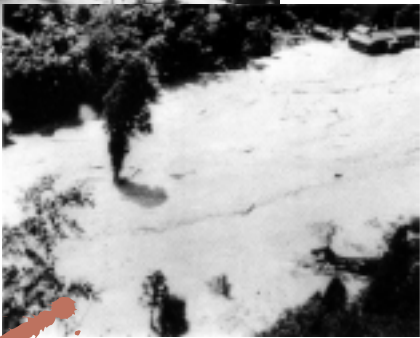
After the disaster  
(Photos taken by Mr. Yamamoto in Omachi City)

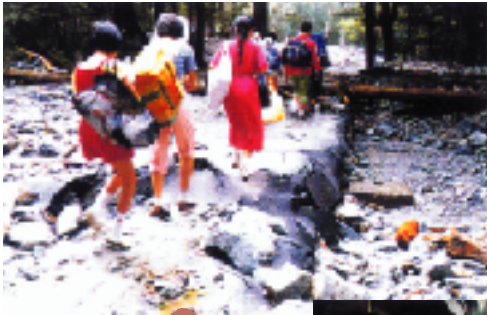
August 22, 1979

Kamikochi suffered a torrential downpour whose maximum precipitation per hour was 50mm and continuous precipitation was 285mm under the influence of typhoon No. 11. A large quantity of sediment generated a debris flow, which cut off the Prefectural Route Kamikochi-koen. The route was closed to all vehicles. As the result of it, 3,000 tourists were kept confined for a week.

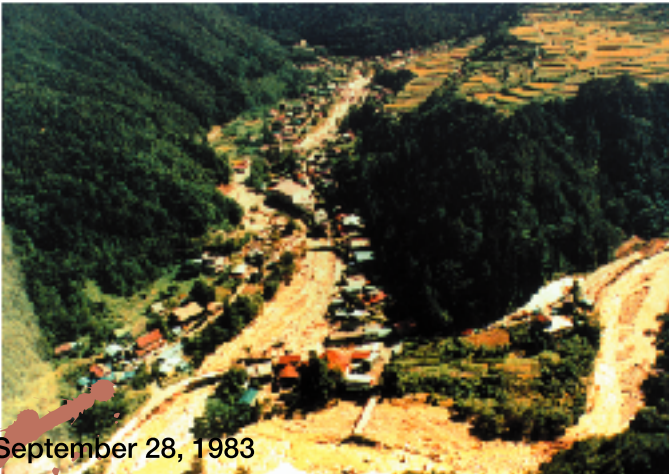
A torrential downpour occurred during the last stage of the rainy season, and a heavy rain fell that recorded the total precipitation of 400mm locally. The surface of a mountain collapsed all over the drainage areas of the Himekawa River. A debris flow occurred in 38 locations of the Himekawa River system, which cut off the route. Four hundred and twenty-five households in 19 villages became isolated from the outside. Service on the JR Oito Line was suspended over a long period, too. Moreover, the sediment flowed into the Honkawa River from its branches, and became accumulated. For this reason, the river bed rose by more than 10m at the location that was hit hardest. A deluge flowed down the Honkawa River accompanied by a large quantity of sediment, which broke the embankment of Itoigawa City in the lower reaches. Fifty-four houses were destroyed either completely or partially. Four hundred and fifty houses were inundated either above the floor level or below the floor level. Thus, the area suffered a great deal of damage.

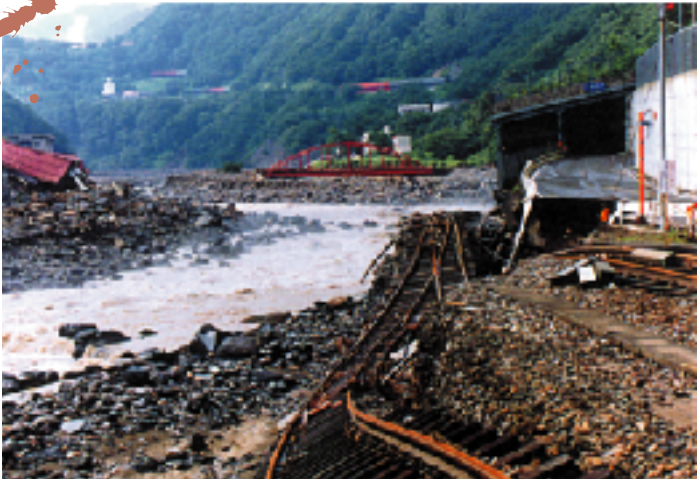
The rain that kept falling day after day under the influence of typhoon No. 10 recorded the maximum precipitation per hour of 37mm and the total precipitation of 289mm. The collapsing sediment and the woody debris that flowed out from the upper reaches broke the embanks on both sides of the main Nakawa River. The public facilities and the houses were washed away, and the route was cut off. The Village was isolated from the outside. The amount of damage reached 5.6 billion yen.

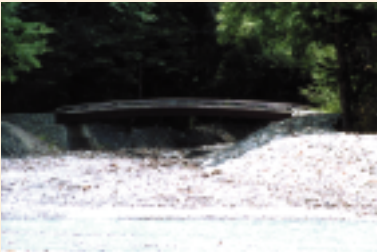
Photo taken in 2000

The photo shows the Shirosawa bridge near the juncture at Shirosawa in the upper reaches of the Azusagawa River. It is obvious that the aggradation occurred even during a brief period from 1992 to 2000.

### Shirosawa bridge near the juncture at Shirosawa

Upon formation of Taishoike Pond after the Azusagawa River was dammed up by Mt. Yakedake erupted in 1915, the sediment discharged from the Azusagawa River became cut off completely, which aggravated silting up in the upper reaches, and the caused the aggradation.
