新潟県中越地震による下之沢(梶金)地区の土砂災害

Sediment disaster caused by the Mid Niigata Prefecture Earthquake in 2004 (Shimonosawa/Kajigane Area)

下之沢(梶金)地区の地すべり対策事業

Landslide countermeasures in the Shimonosawa/Kajigane Area

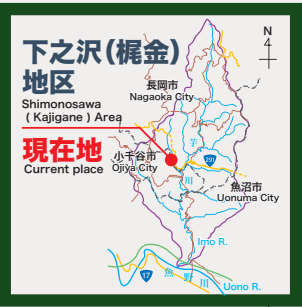
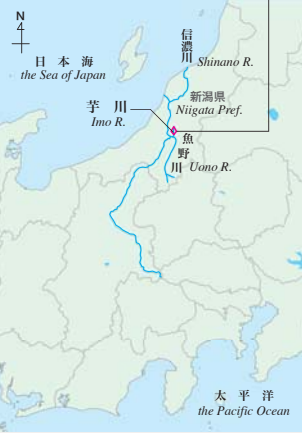
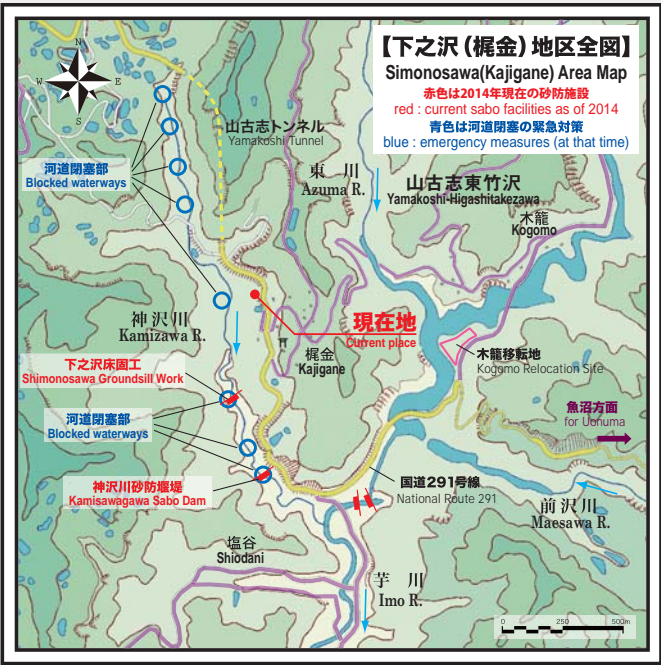
下之沢(梶金)地区全景
Panoramic view of Shimonosawa (Kajigane) Area

下之沢(梶金)地区は芋川支流の神沢川下流部に位置し、地区のほぼ全域が大きな地すべり地形の中にあります。地震によって地すべりが移動し、地区全体が大きな被害を受けました。

The Shimonosawa/Kajigane area is located downstream along the Kamizawa river, a tributary of the Imo river, and nearly all of it was within a large landslide configuration. The whole area was severely damaged by the earthquake, which had caused a serious landslide.

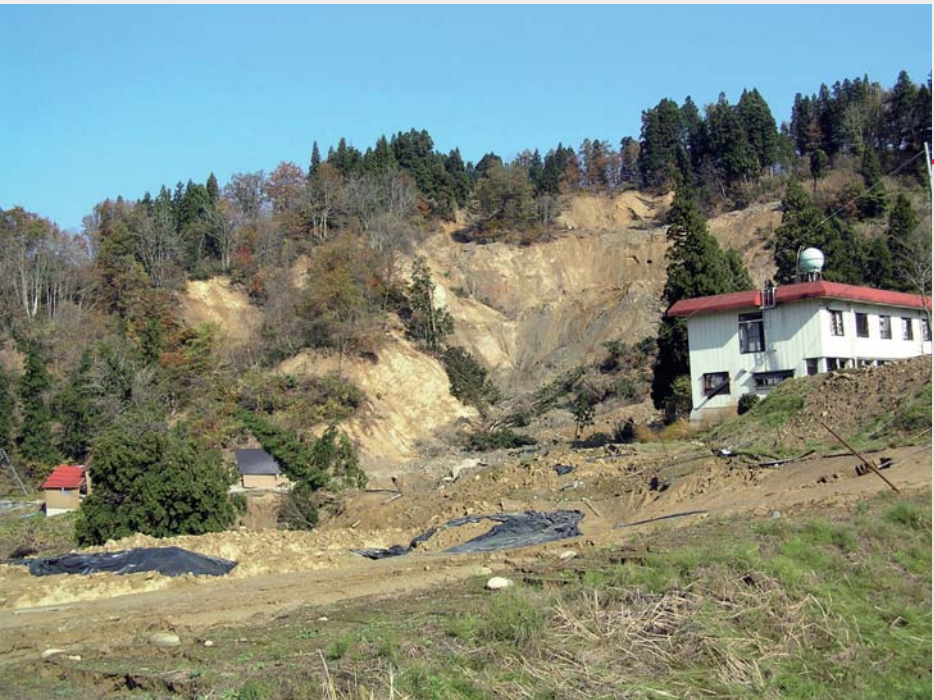
地震による山腹崩壊状況
The hillside collapse by the earthquake

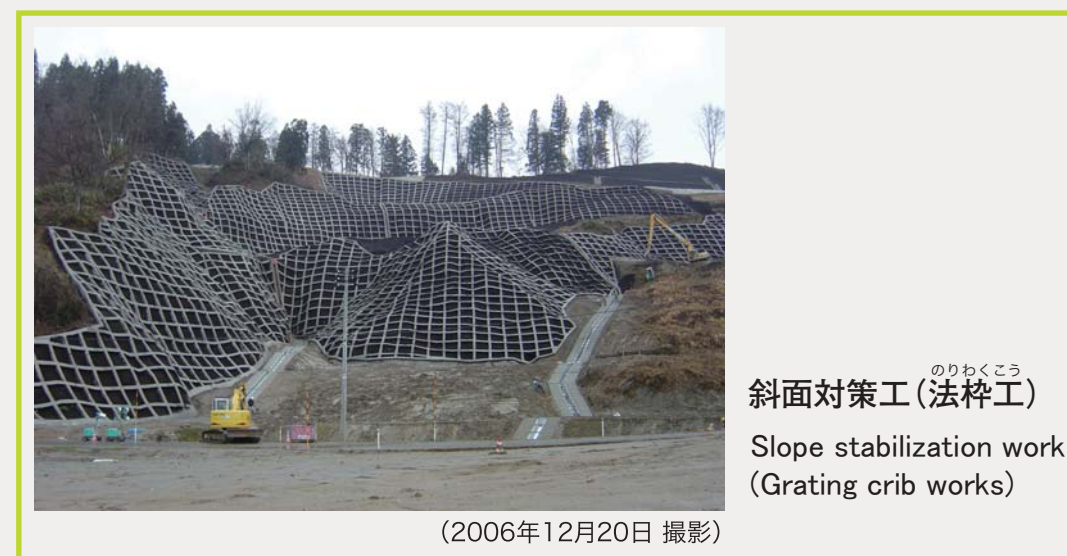
(2006年12月20日 撮影)

斜面对策工 (法枠工)
Slope stabilization work (Grating crib works)

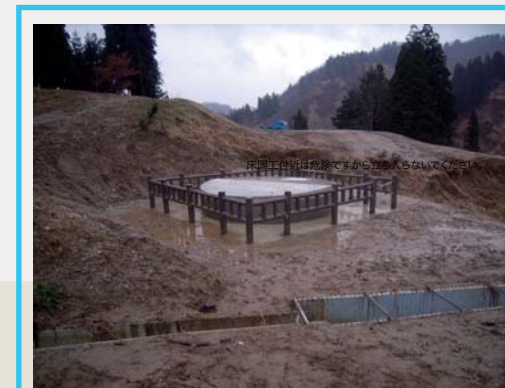
(2006年12月22日 撮影)

地下水を排水する集水井
Water catchment well (Underground water that causes landslides is collected for drainage.)

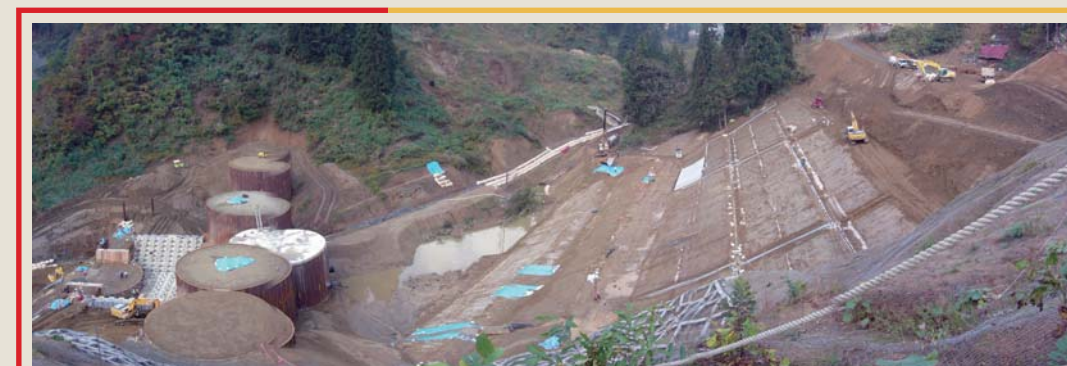
(2006年11月15日 撮影)

床固工(セル型)と、地すべり土塊を押さえる盛土工。工事の様子。
Groundsill work (steel sell) and filling works to fasten lower part of the landslide.
